# Manhole Inspection Summary

Manhole # S37II\_010MH

Insp Date: **3/16/07 10:50 AM**

**Location** Address: **418 LANVALE ST**

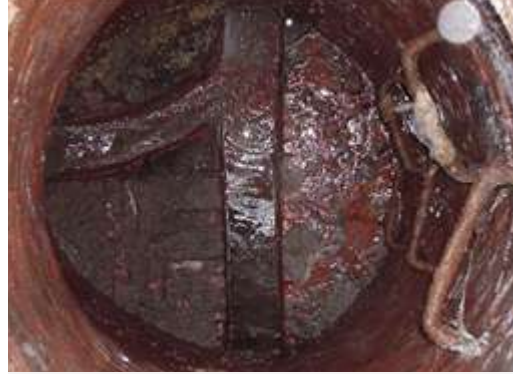
Top View

Corroded steps. Evidence of surcharge - Bench debris.

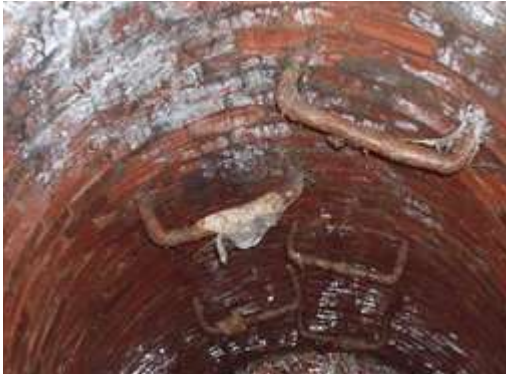
Defect

Adjustment and Corbel infiltration.

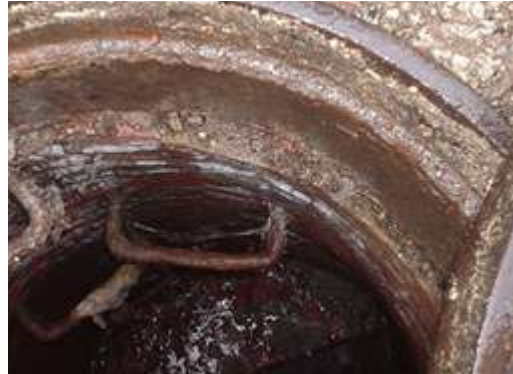
Defect

Frame leaks. Frame offset.

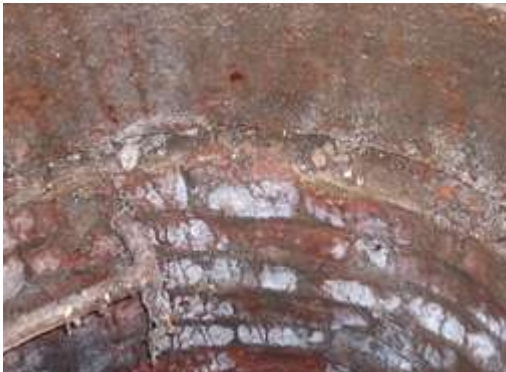
Defect

Frame leaks. Adjustment deterioration and infiltration.

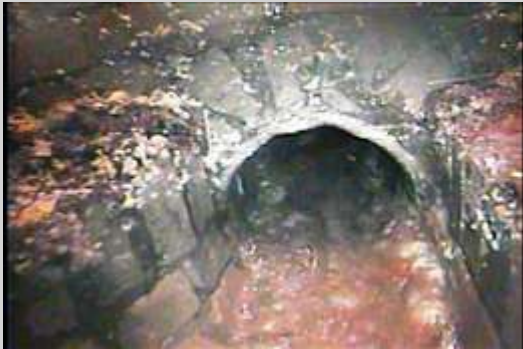
### 8 in. Circular Gravity Sewer Pipe Out @ 12 O'Clock

Deposits: ☐ None ☐ Mud ☐ Sludge ☐ Debris ☒ Grease

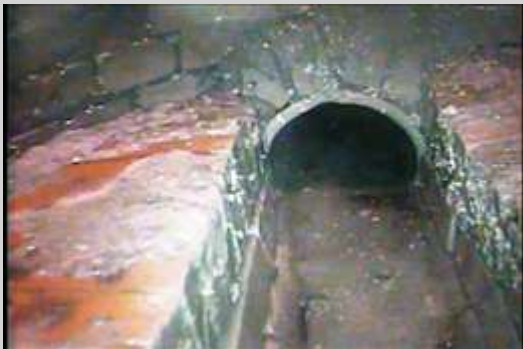
### 8 in. Circular Gravity Sewer Pipe In @ 6 O'Clock

Channel deterioration.

Deposits: ☐ None ☒ Mud ☐ Sludge ☒ Debris ☐ Grease
